**Asbestos Bridge
Inspection/Survey**

Moraga Road Bridge

August 27, 2015

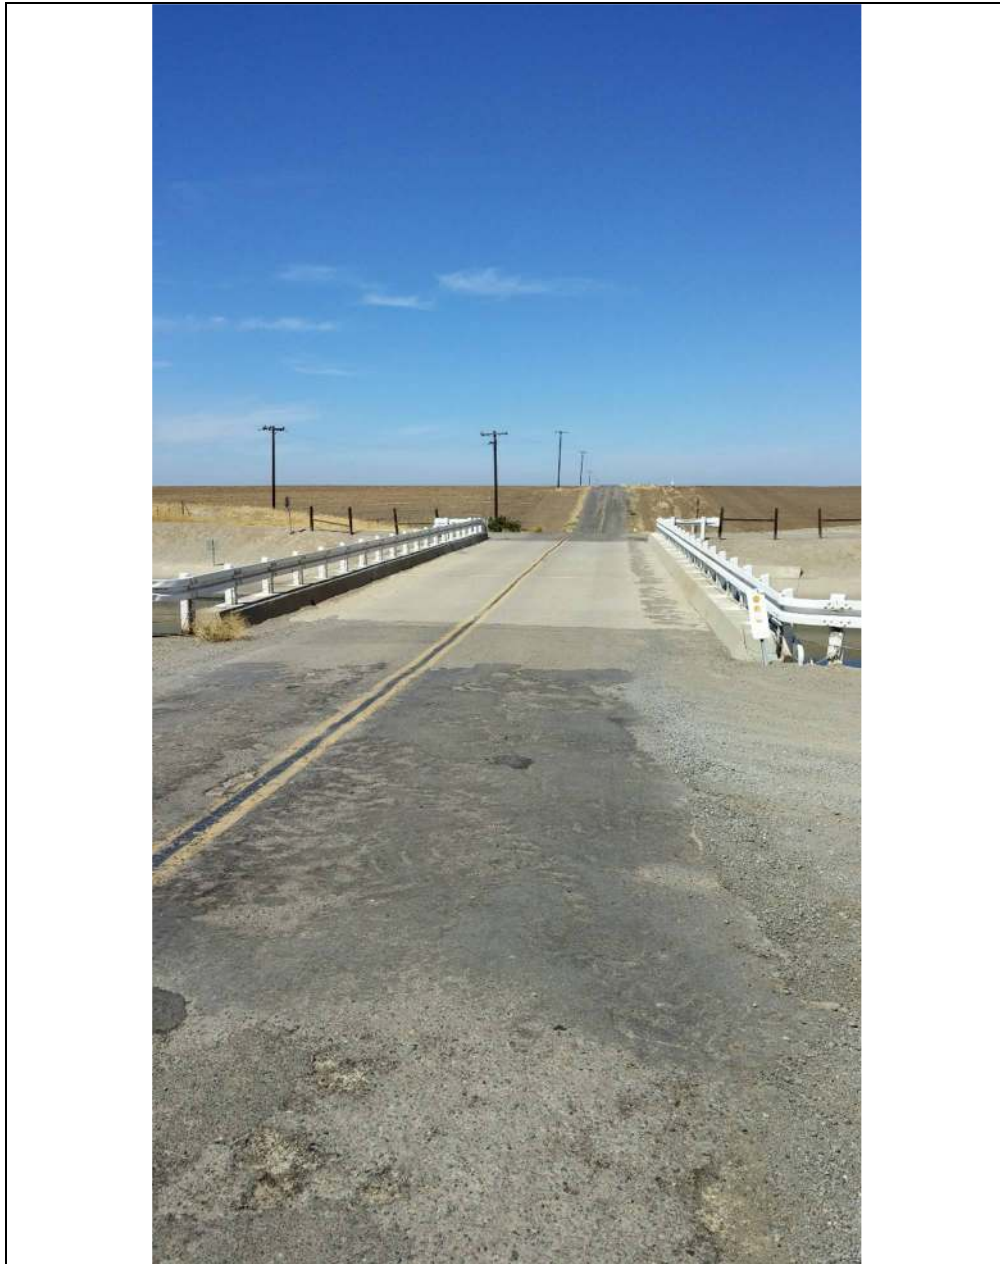
Photograph # 1	Moraga Road Bridge

Date of Inspection:	August 27, 2015	
Subject:	Bridge Span, Facing N

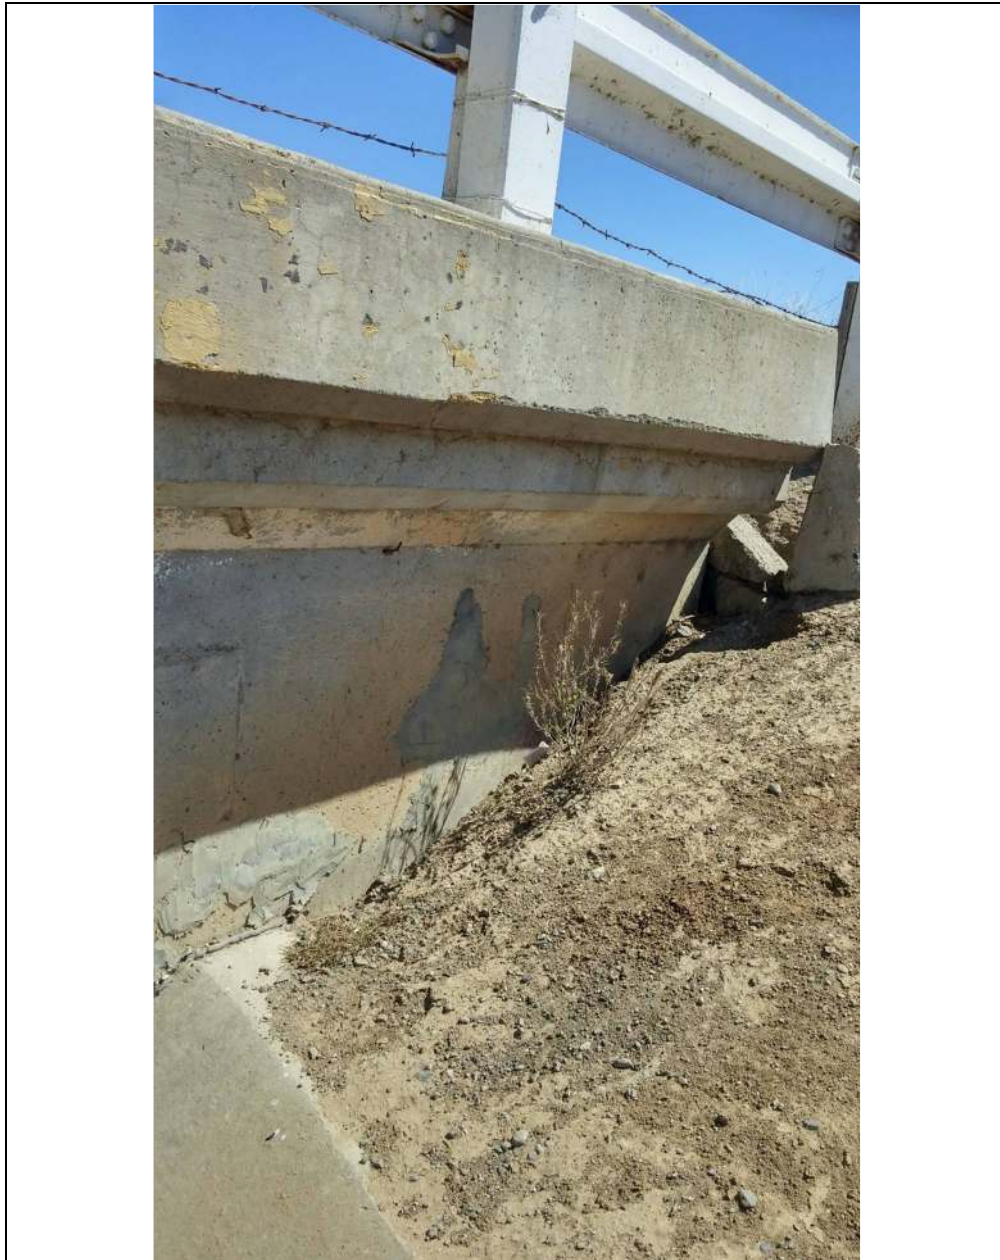
Photograph # 2	Moraga Road Bridge

Date of Inspection:	August 27, 2015	
Subject:	Southwest Deck-Abutment

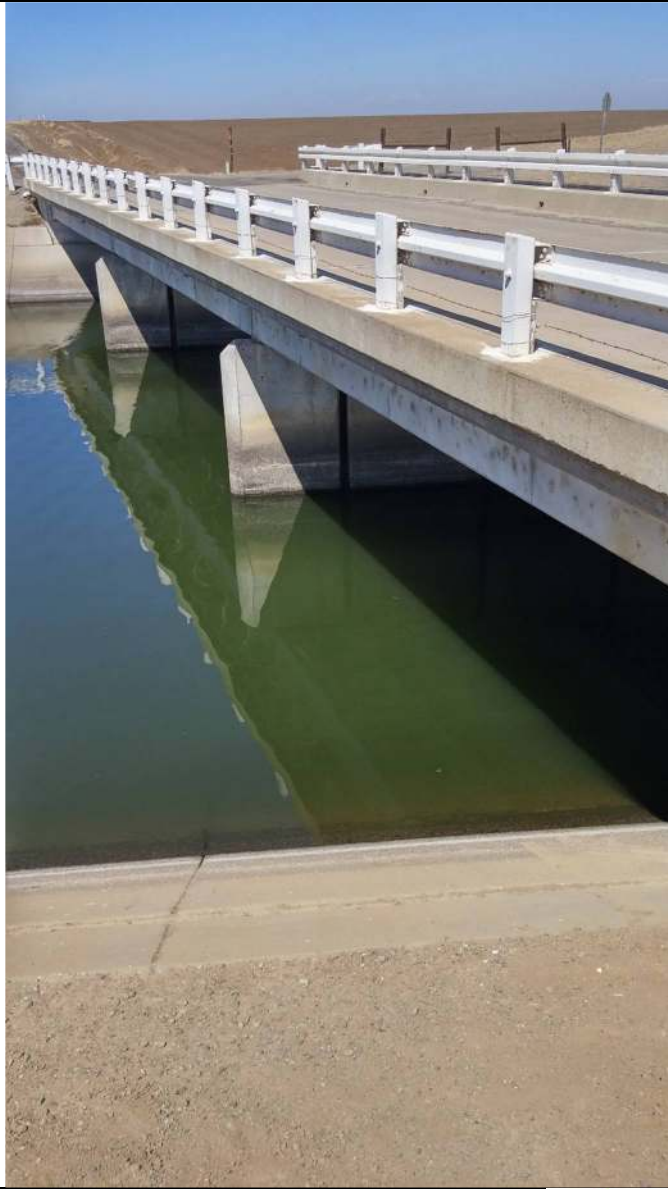
Photograph # 3	Moraga Road Bridge

Date of Inspection:	August 27, 2015	
Subject:	West Side Exposure

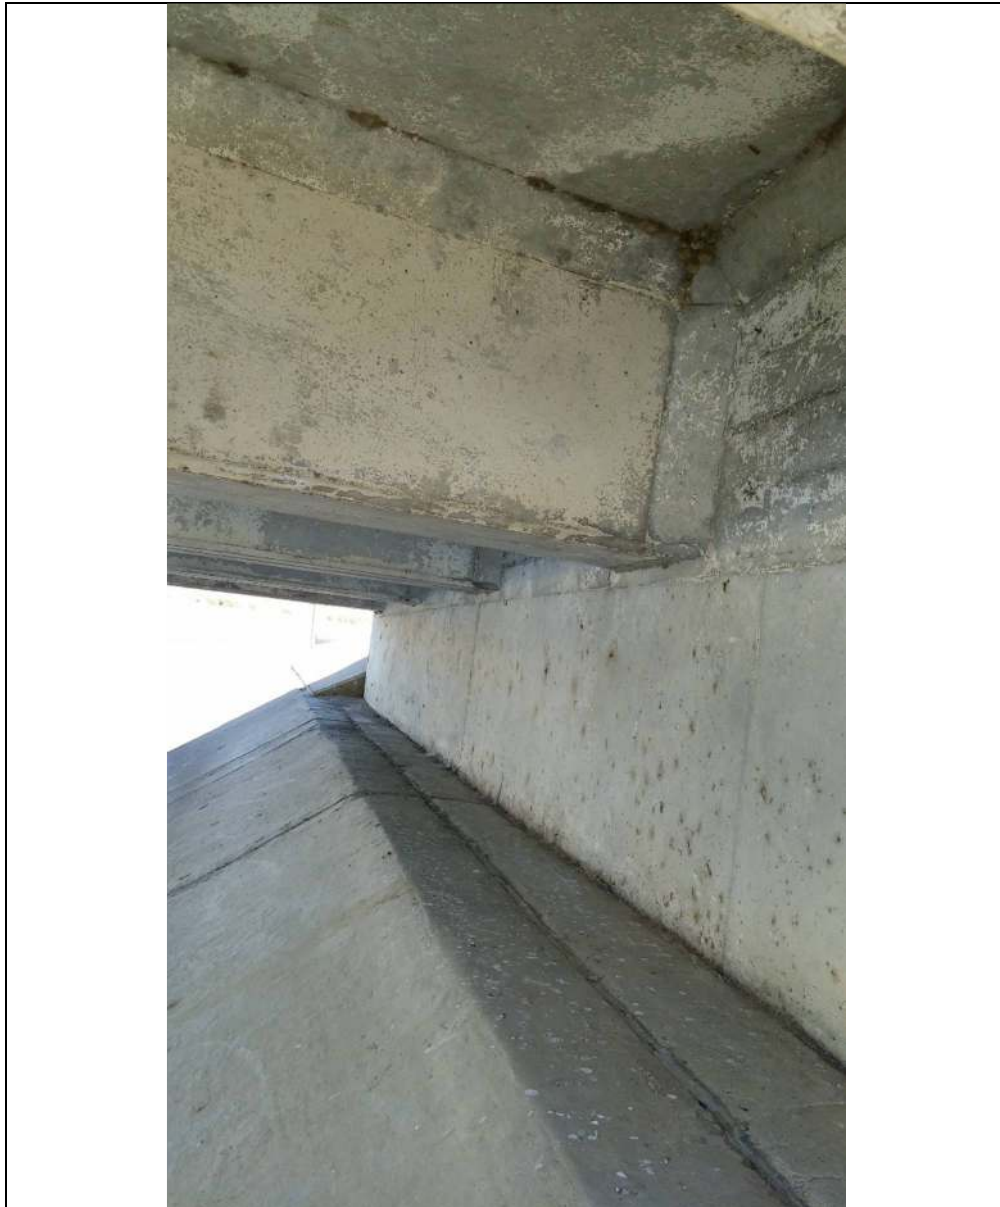
Photograph # 4	Moraga Road Bridge

Sample ID#	Material Description	Sample Location	Category	Results
MRF-9	Black Sealant	North Abutment At Aqueduct Wall- Abutment Intersection (approx. -20 sf)	I	5% Chrysotile

The Black Sealant is found at the aqueduct wall/abutment intersection on both sides of the bridge (approximately ~20 sf). The depth of the material is not known. Federal and state regulations require that anyone disturbing asbestos containing materials are properly trained certified and have the required respiratory protection and medical surveillance.

Date of Inspection:	August 27, 2015	
Subject:	North Abutment – Sample 9

N.A.L. recommends that a certified asbestos abatement contractor be retained to remove the non-friable materials prior to any scheduled renovation/demolition work being completed at the site. Prior to the work process starting, a work plan or specifications in regards to the abatement process should be completed and distributed to the abatement contractors during the job walk at the site.

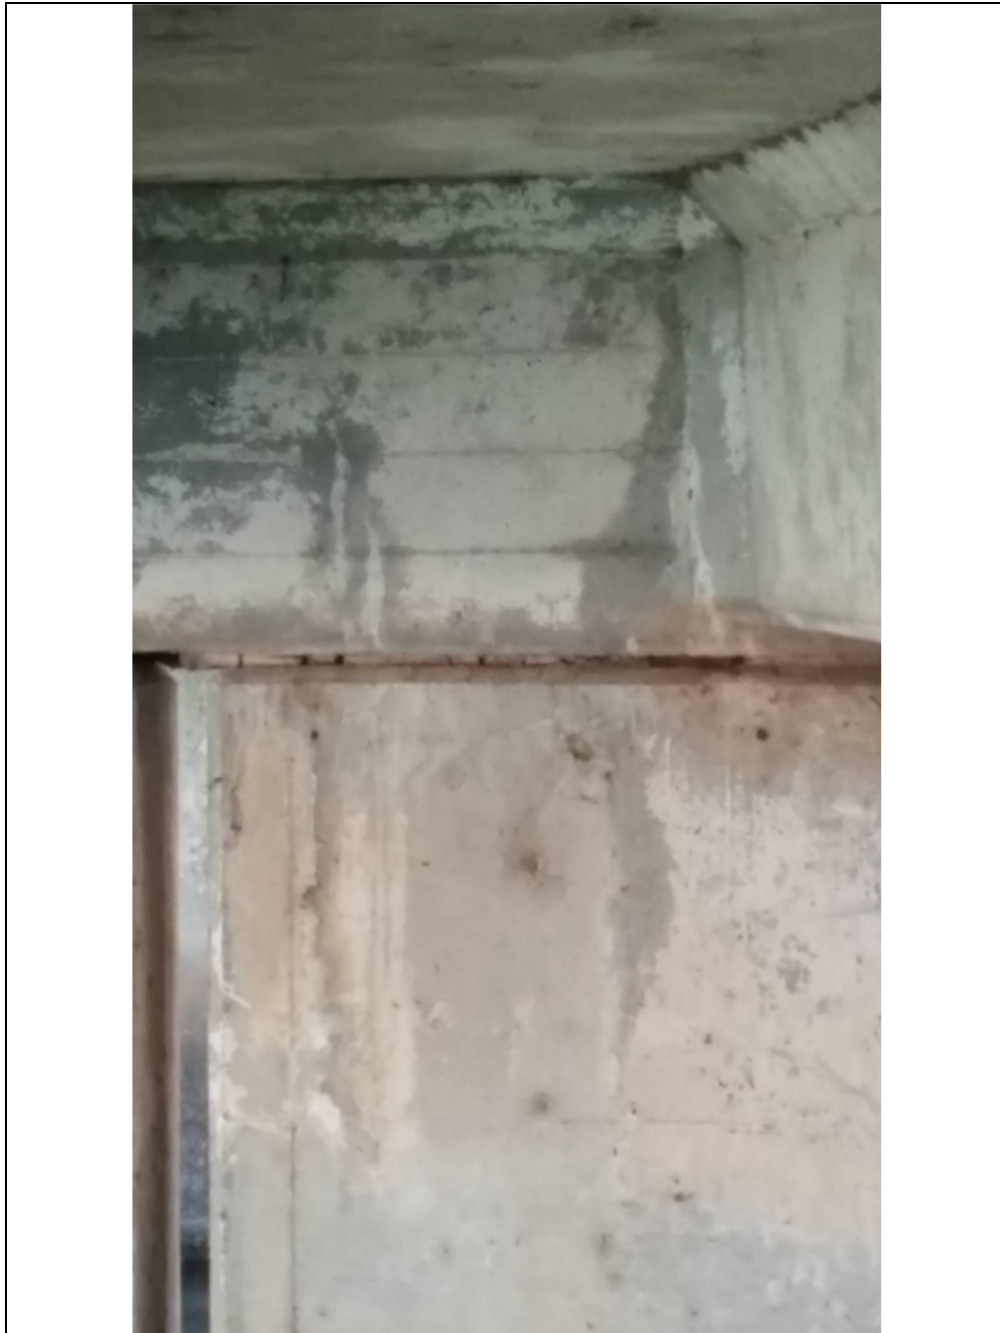
Photograph # 5	Moraga Road Bridge

Date of Inspection:	August 27, 2015	
Subject:	Pier-Deck Intersection

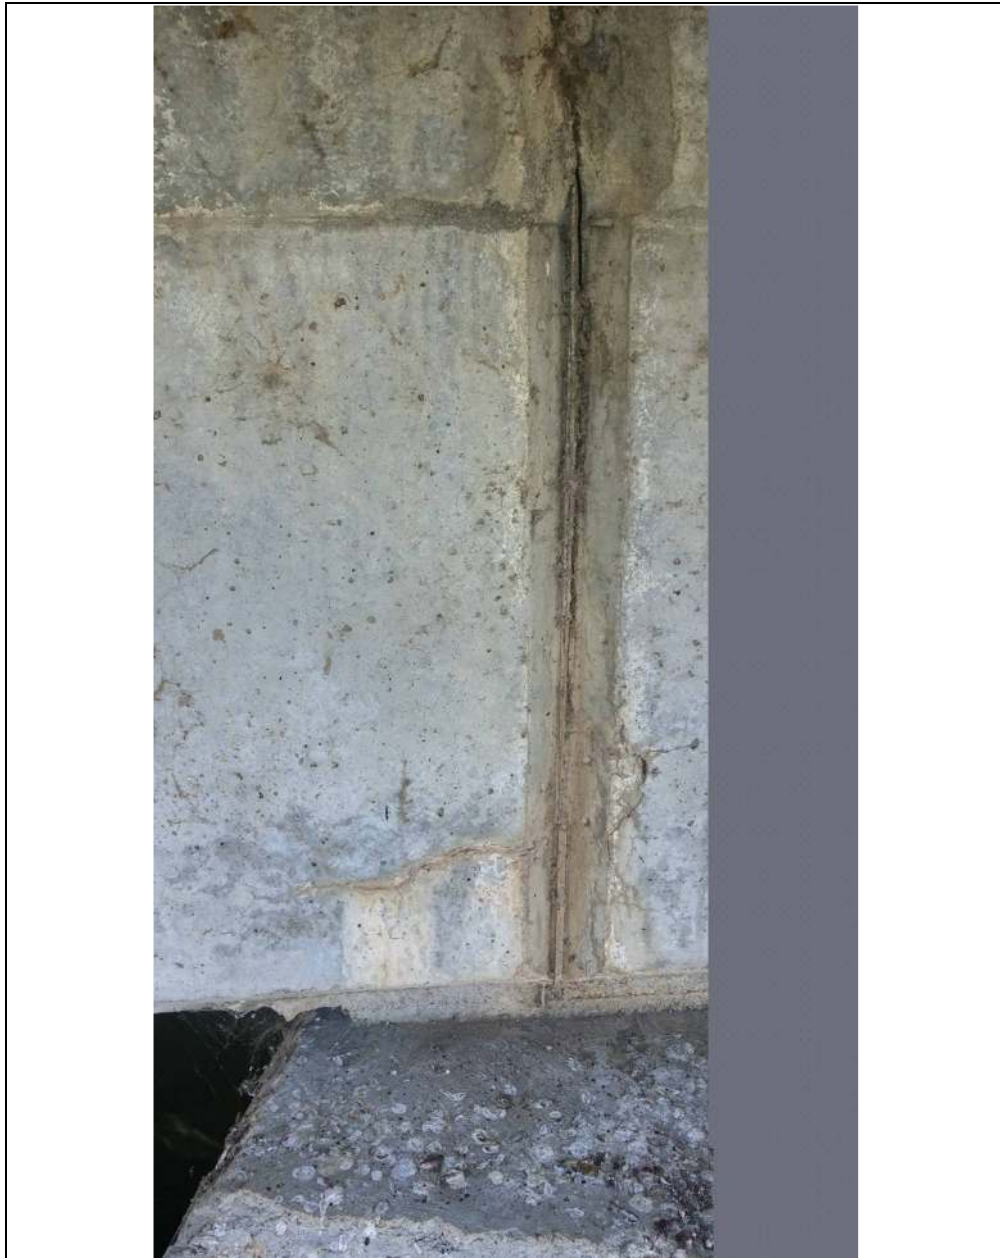
Photograph # 6	Moraga Road Bridge

Date of Inspection:	August 27, 2015	
Subject:	Deck Slab Joint at Deck-Pier Intersection with Slurry

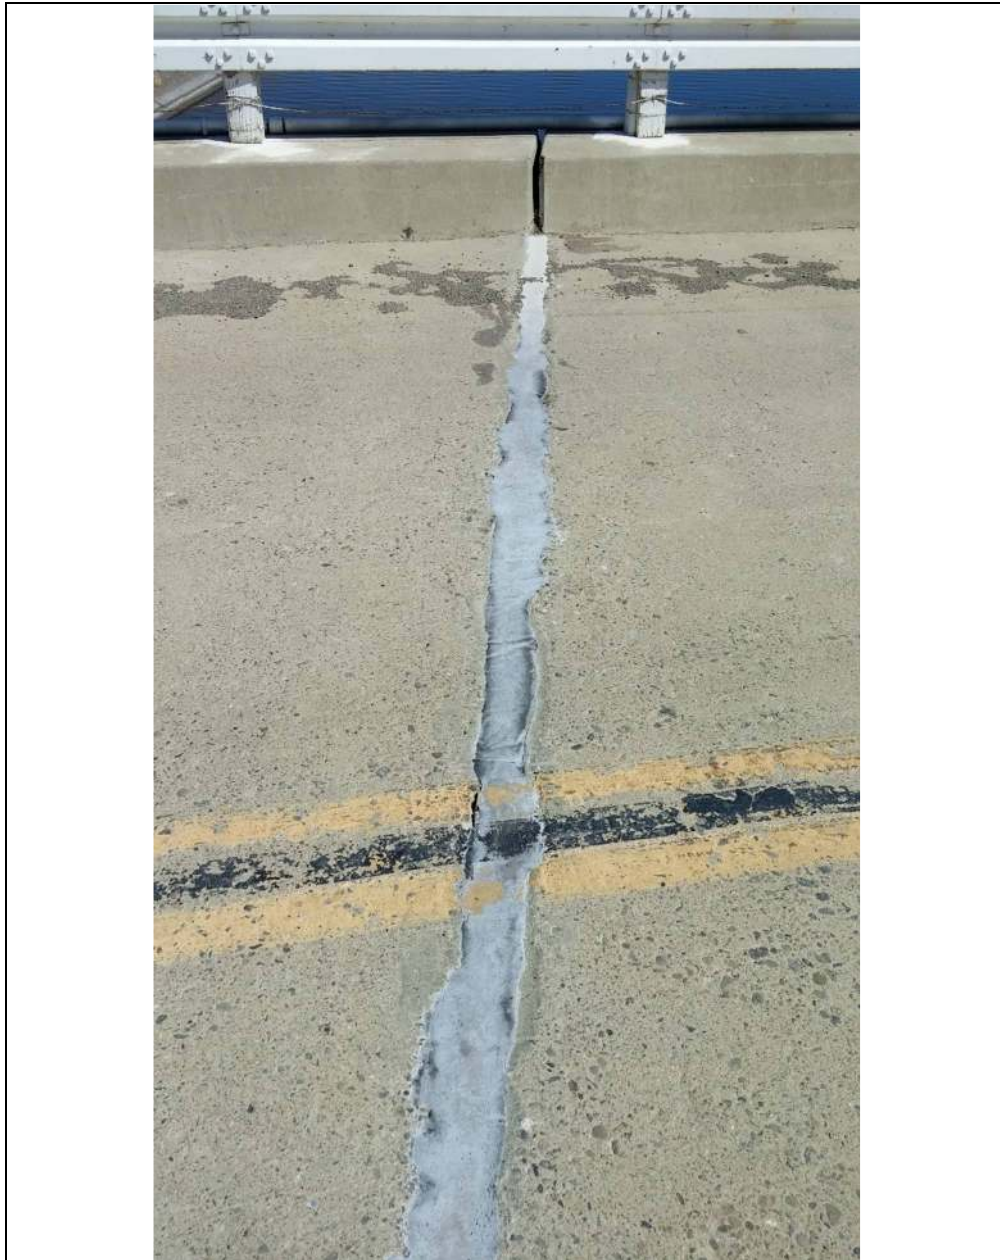
Photograph # 7	Moraga Road Bridge

Date of Inspection:	August 27, 2015	
Subject:	Rubberized Center Sealant
