**Asbestos Bridge
Inspection/Survey**

Moraga Road Bridge

August 27, 2015

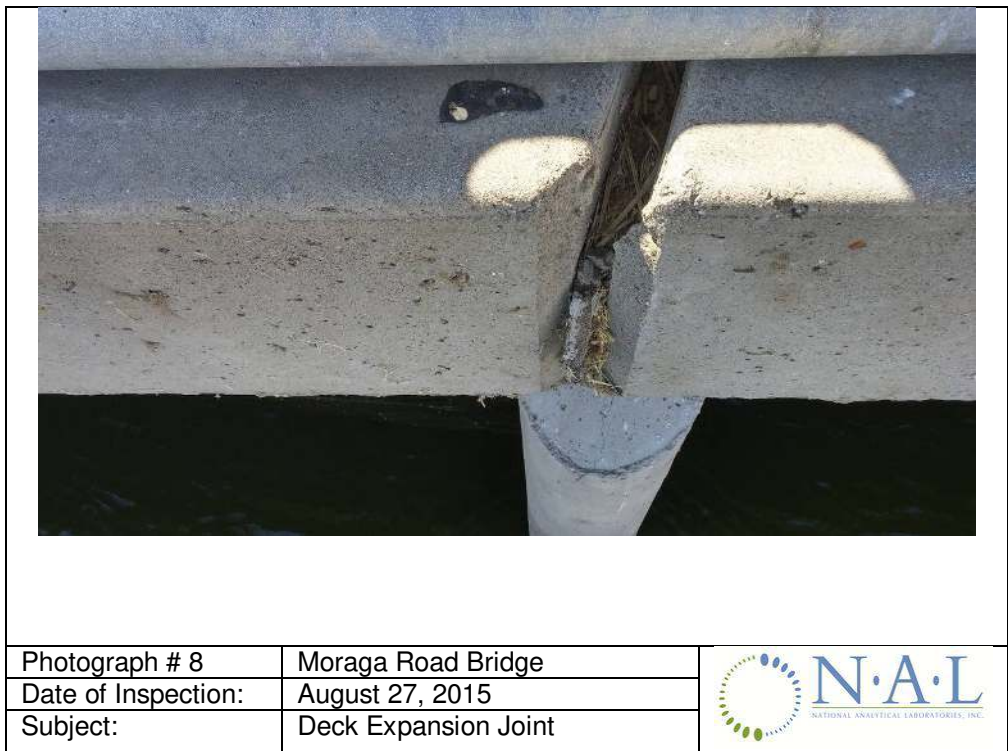
Based on the asbestos sample results collected from the specific bridge materials tested, the Black Sealant (approximately ~20 sf) was found to contain ACCM. All square footage should be verified by contractor.

The Black Sealant is found at the aqueduct wall/abutment intersection on both sides of the bridge (approximately ~20 sf). The depth of the material is not known. Federal and state regulations require that anyone disturbing asbestos containing materials are properly trained certified and have the required respiratory protection and medical surveillance.

N.A.L. recommends that a certified asbestos abatement contractor be retained to remove the non-friable materials prior to any scheduled renovation/demolition work being completed at the site. Prior to the work process starting, a work plan or specifications in regards to the abatement process should be completed and distributed to the abatement contractors during the job walk at the site.
